STAFFORD, CONNECTICUT

WARREN POND DAM
00335

PHASE I INSPECTION REPORT
NATIONAL DAM INSPECTION PROGRAM

AUGUST 1980

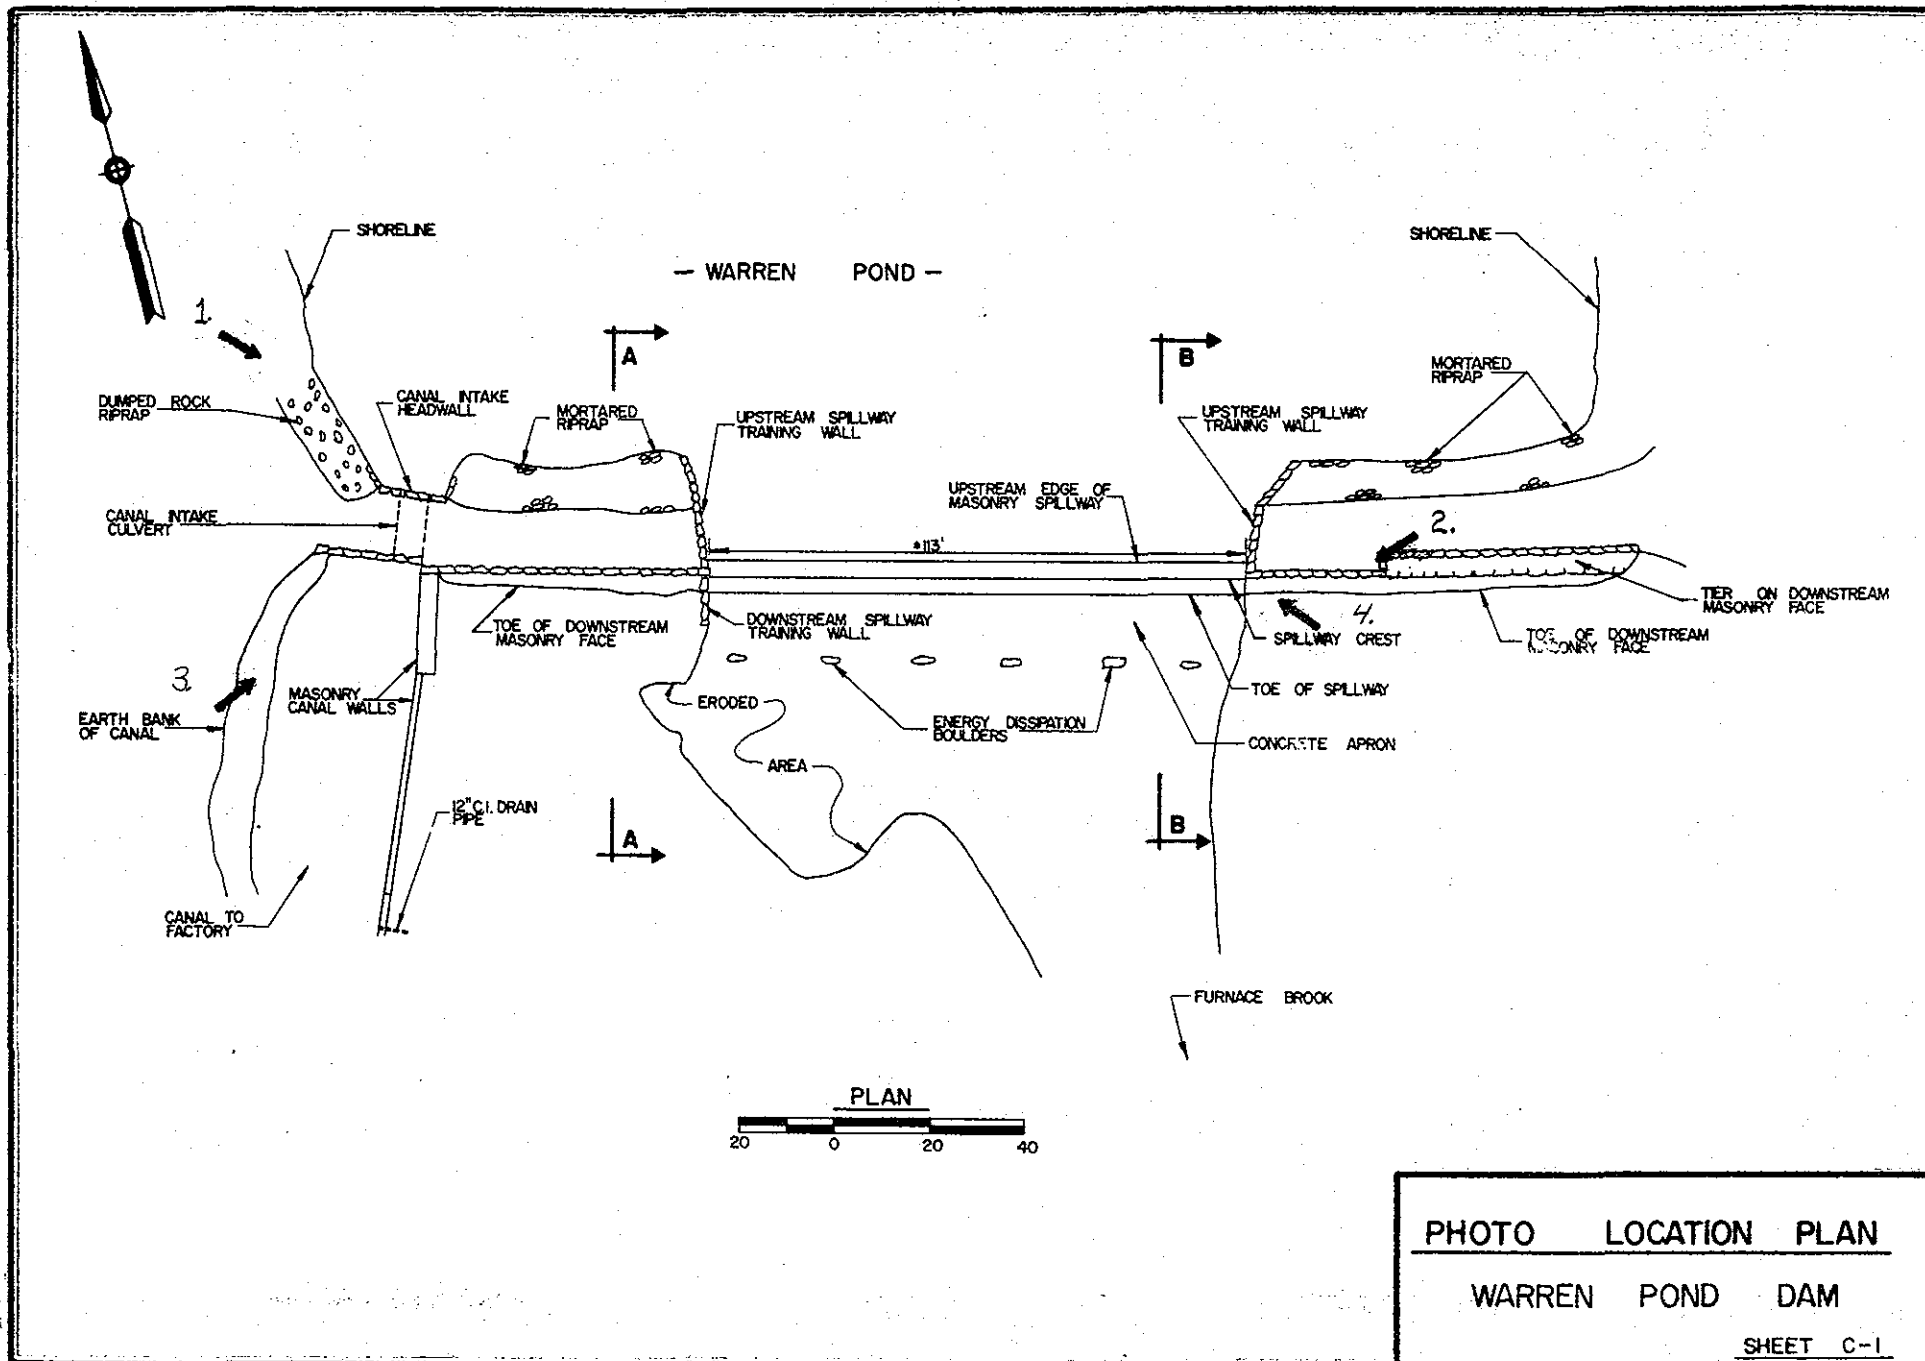
Top of Dam - The grass covered top of the dam is irregular and gradually sloping to the spillway walls from both abutments (Photos 1 and 2).

Spillway - The masonry spillway crest is in good condition. No substantial obstructions of the approach channel or crest were observed (Photos 1 and 2). The training walls adjacent to the spillway crest were cracked, with joint openings between blocks of up to 2 inches. The concrete apron at the toe of the spillway could not be observed, due to the amount of water flowing onto it from over the spillway. The energy dissipation boulders on the apron were sparse towards the right side of the channel and, consequently, there is extensive erosion and uprooted trees along the right side of the downstream channel (Photos 2 and 5).

c. Appurtenant Structures - The masonry culvert through the right embankment section of the dam and the outlet canal are both in poor condition (Photos 1 and 3). There is no gate hoisting mechanism on the upstream headwall of the culvert. Fallen masonry blocks at the right corner of the upstream headwall of the culvert were observed, leaving exposed and eroded earthfill. The left masonry wall of the outlet canal, with concrete coping on the top, was deteriorated with numerous cracks in the concrete and opened, weathered masonry joints. There is a 12 inch cast iron drain pipe

Photo 1 - Upstream slope and top of dam. Upstream headwall of canal intake culvert in foreground (3/24/80).
